Released Engineering Change Notice

Product	PA-CP
Title	IDC header clamp AL6912 no longer used
Date	23/09/2010

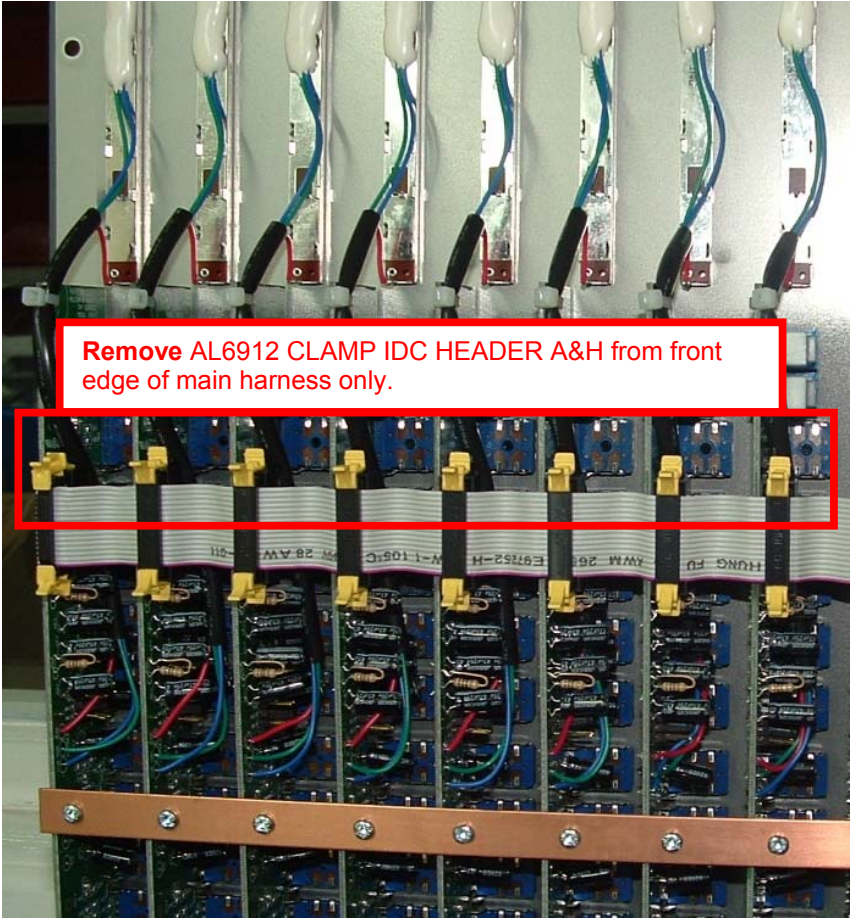
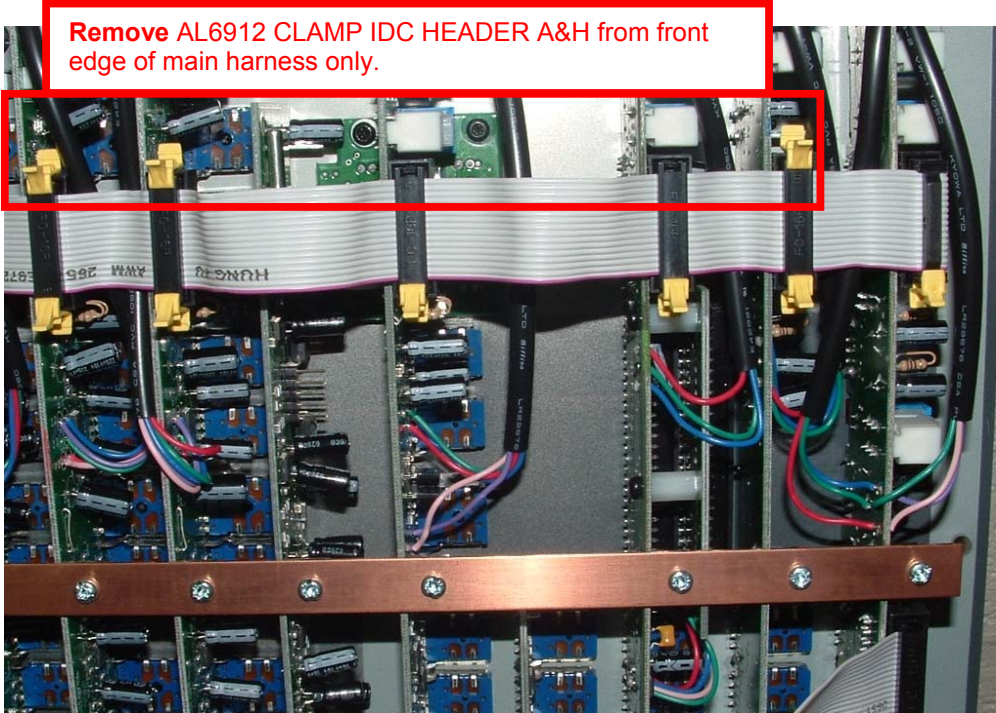
For all versions of PA122-CP and PA202-CP remove AL6912 CLAMP IDC HEADER A&H from the front edge of the main harness only.

003-497 MAIN ASSY PA 122-CP – Remove x11 AL6912 CLAMP IDC HEADER A&H (see attached photos)

003-499 MAIN ASSY PA 202-CP – Remove x19 AL6912 CLAMP IDC HEADER A&H (same as PA122 , plus additional inputs)

Reason for change
Reports of clamps falling off during transit due to contact with base screen plate.
